# City of Henderson Fire Department

## Informational Final Report of Near-Miss Incident

May 1, 2010

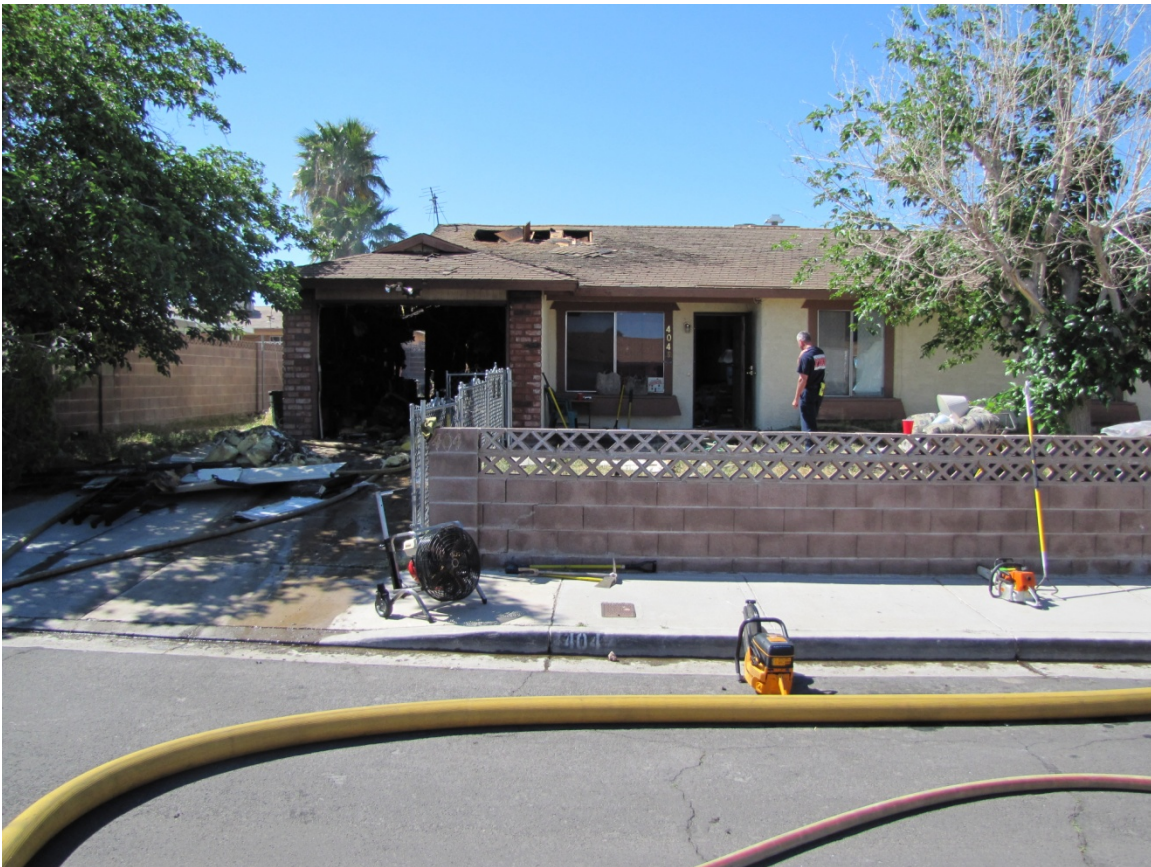
**Figure 1: A side of structure showing garage and ventilation holes.**

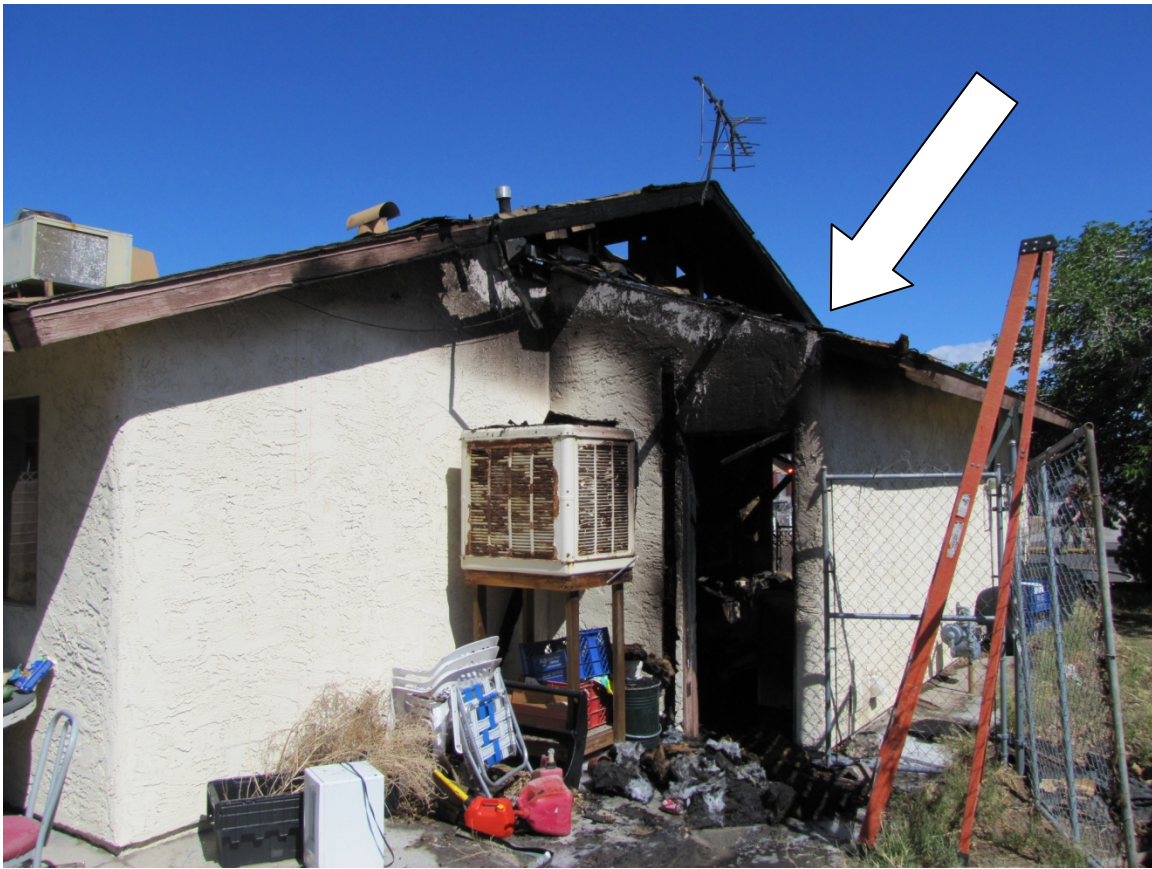
**Figure 2: B side of structure showing roof/attic fire damage. Arrow points to area FF fell through on the lower roof.**

A FF fell through a soft spot in the roof catching himself at his armpits. The FF did not report any injuries; however this event had the potential to create a situation that could have resulted in:

- 1) There is a high potential for this to occur again whenever there is direct fire damage to the supporting roof members of a structure.
- 2) Hazards to personnel can exist during salvage and overhaul operations.
- 3) The identification of a soft or unstable roof requires safety measures to be taken during ALL phases of suppression activities.
- 4) The usage of a roof ladder should have been encouraged.
- 5) Crew members given an informal leadership role cannot also serve as primary workers in order to maintain situational awareness.
- 6) Hazards should be clearly identified and marked if crews will be working near them.

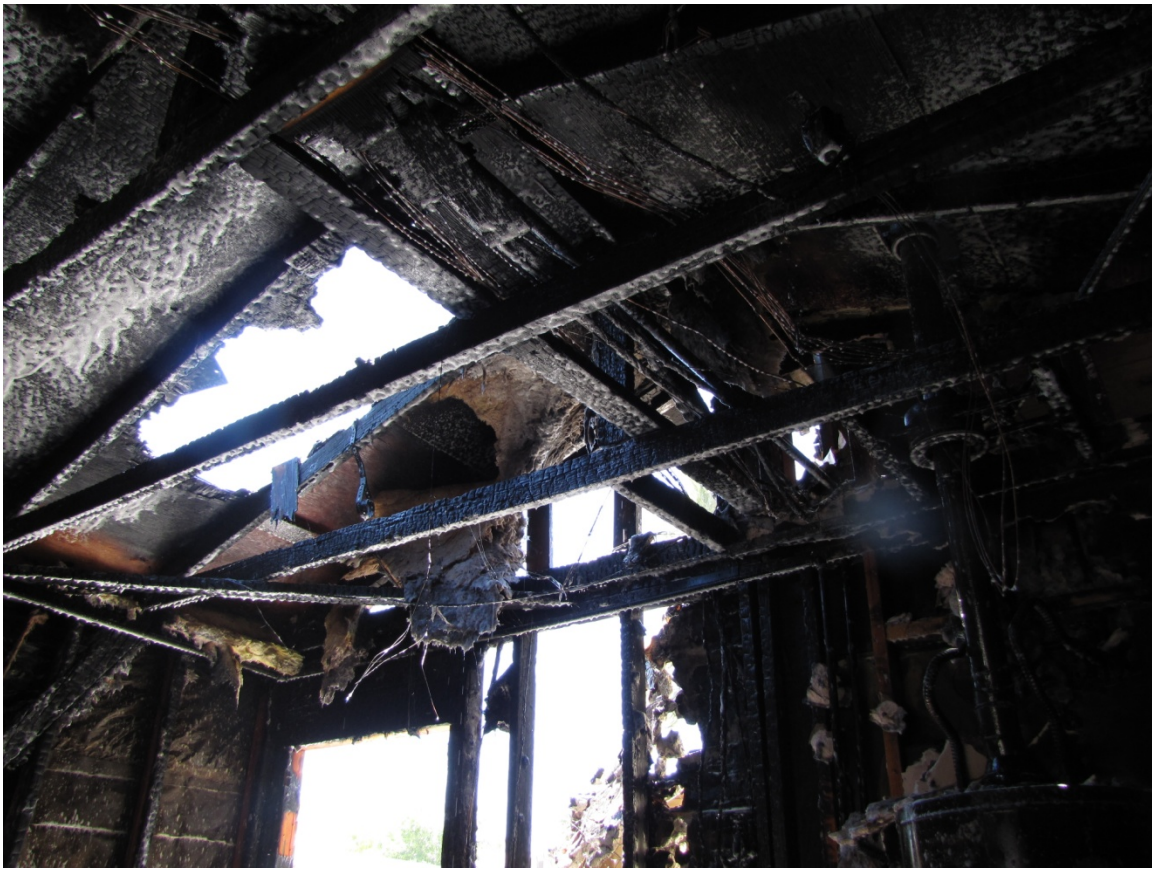
**Figure 3: Interior shot of garage showing fire damage to roof and supporting members. This garage had no sheet rock protection of the supporting roof members.**

- 1) Direct fire impingement to the roof trusses and sheeting material.

- 2) Lack of sheet rock barrier between attic space and garage area.

- 3) House was constructed prior to building codes requiring this type of barrier.

**Root Cause:** Normal fire conditions created the hazard. The house was constructed prior to building codes requiring a barrier to be present between the attic space and the garage. The direct fire impingement to the light weight wood truss roof weakened it, creating the identified hazardous area.
